During 2008 the Department was able to rebuild Henderson Hill Road with the assistance of a \$129,000 Department of Environmental Conservation erosion control grant.

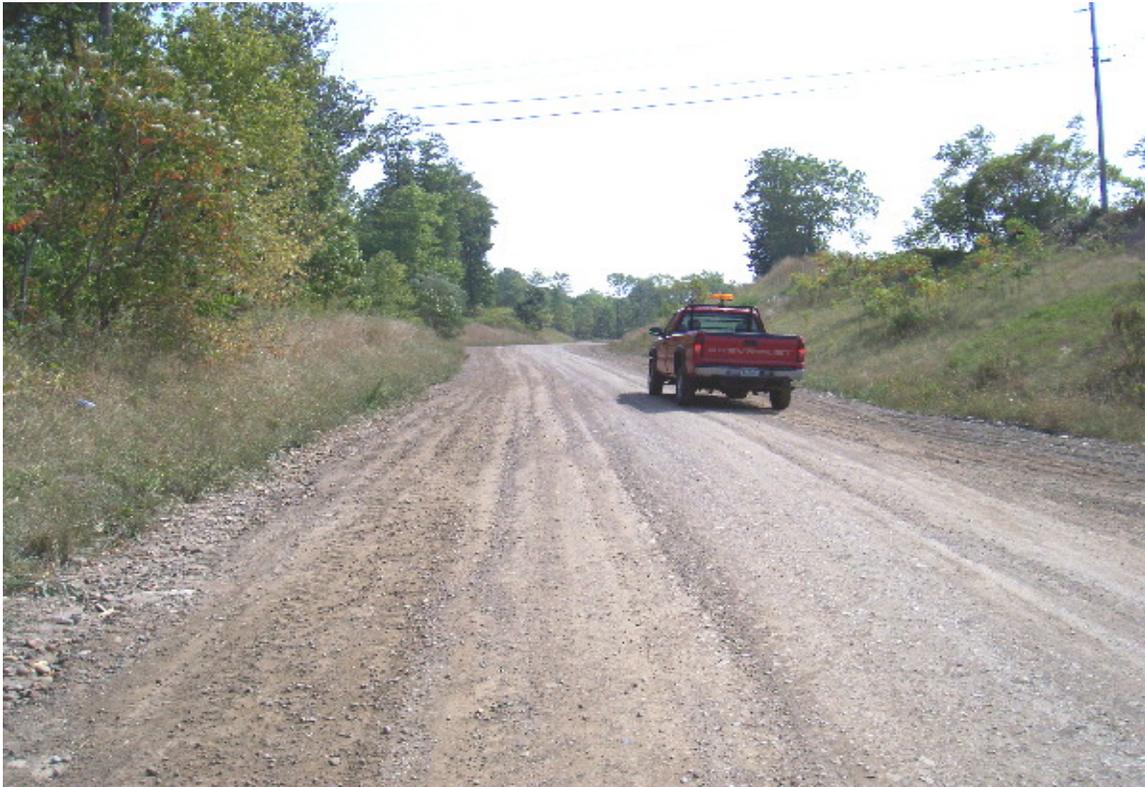
Henderson Hill Road on May 27, 2006. (Looking east)

The road was more dirt than gravel and the ditches were constantly filled with dirt eroding from the road and down the hill towards East Lake Road. The result was tons of dirt and sediment flowing into McMillan Creek located a few feet from Henderson on East Lake Road and subsequently being allowed to enter into Conesus Lake just a few hundred feet from the Henderson Hill Road - East Lake Road intersection.

The ditches were rebuilt using light and medium fill stone and gravel was added to stabilize the road bed. Geo-textile fabric was used as a barrier under the gravel as well as under the fill stone.

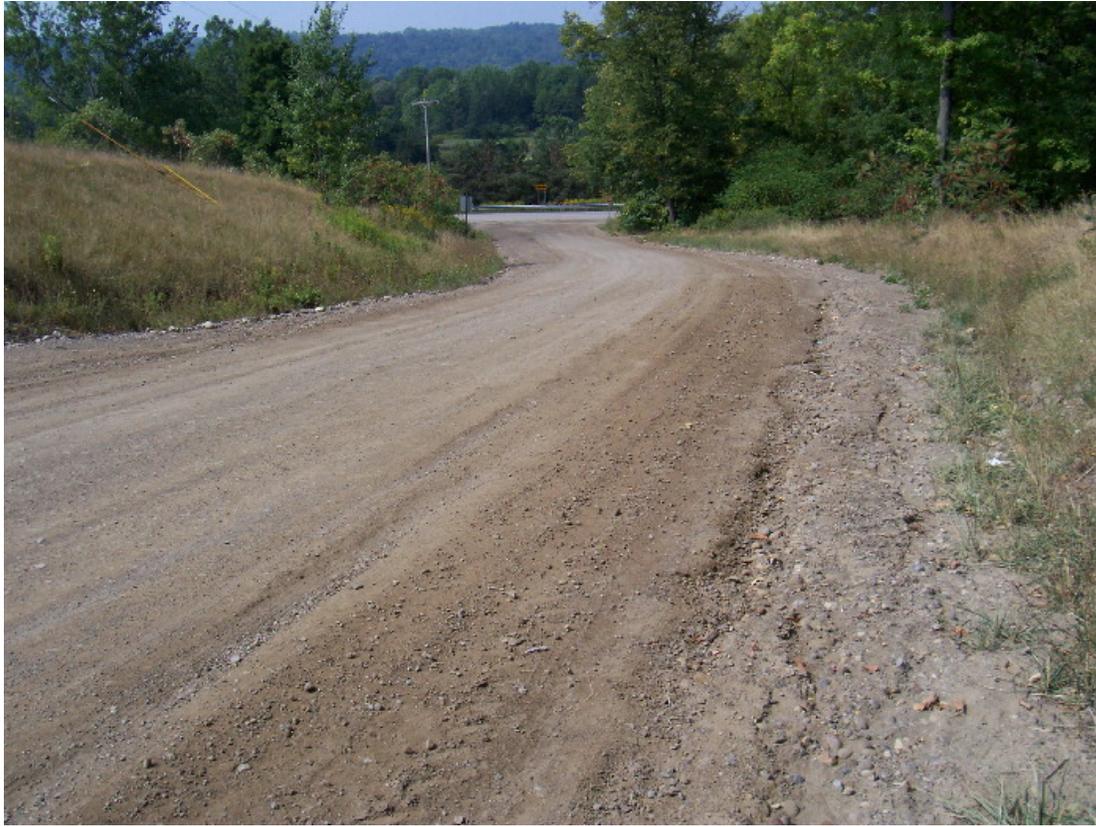
This photo shows the erosion problem (looking west). The East Lake Road is visible in the distance and Conesus Lake is just a few hundred feet further to the west.

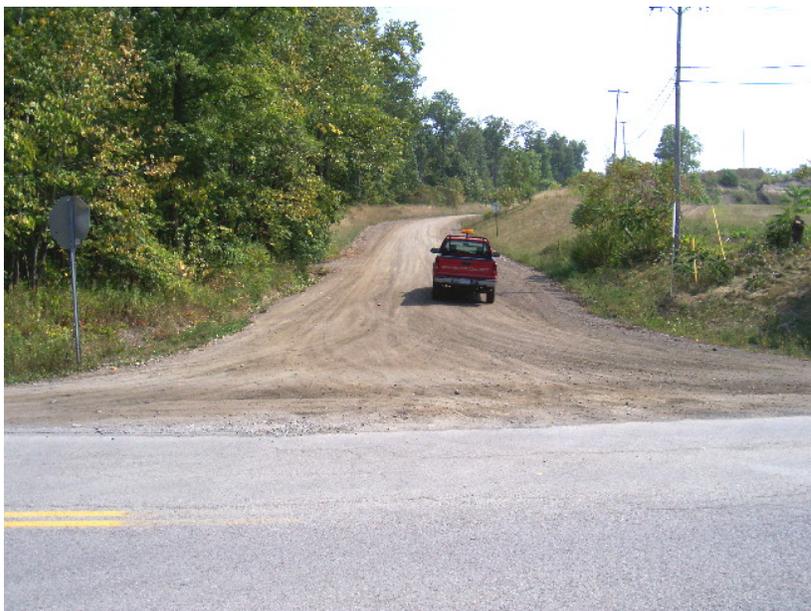
East Lake Road - Henderson Hill Road Intersection in May 2006.

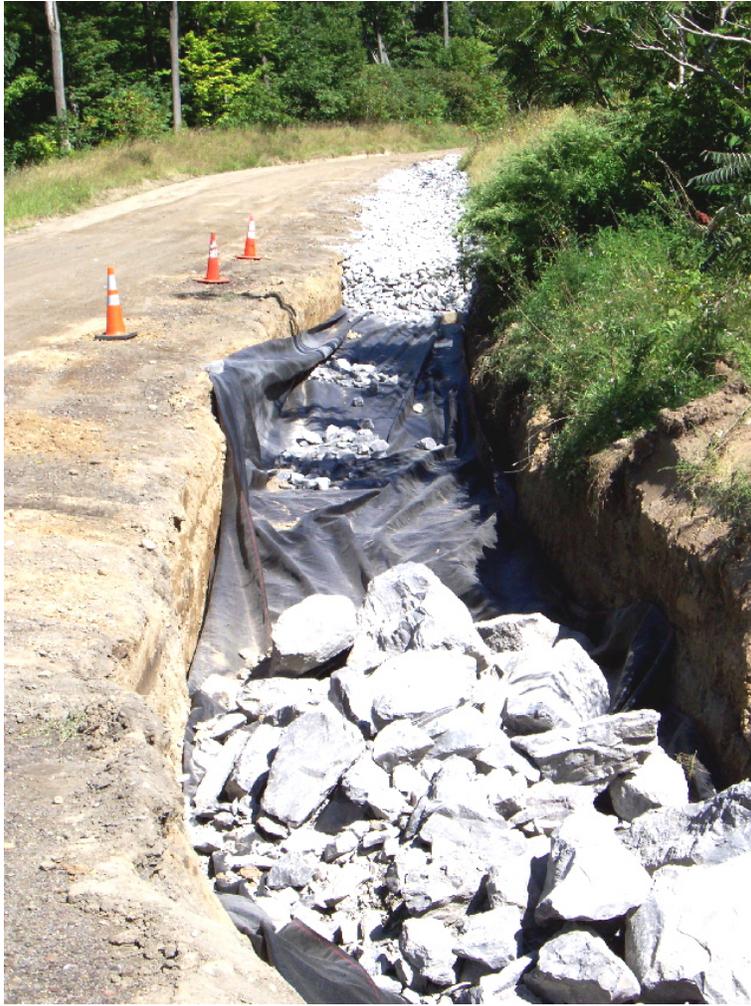
The picture to the left shows the ditch construction. The black material is the geotextile fabric and the larger rock is medium fill stone.

The fabric will help alleviate plant growth as well as ensure there is no erosion under the stone.

The rock not only helps capture sediment but also slows the flow of stormwater.

Culvert pipe was added in critical areas of steep grade to flow the water back and forth under the road further reducing the speed and volume of stormwater.

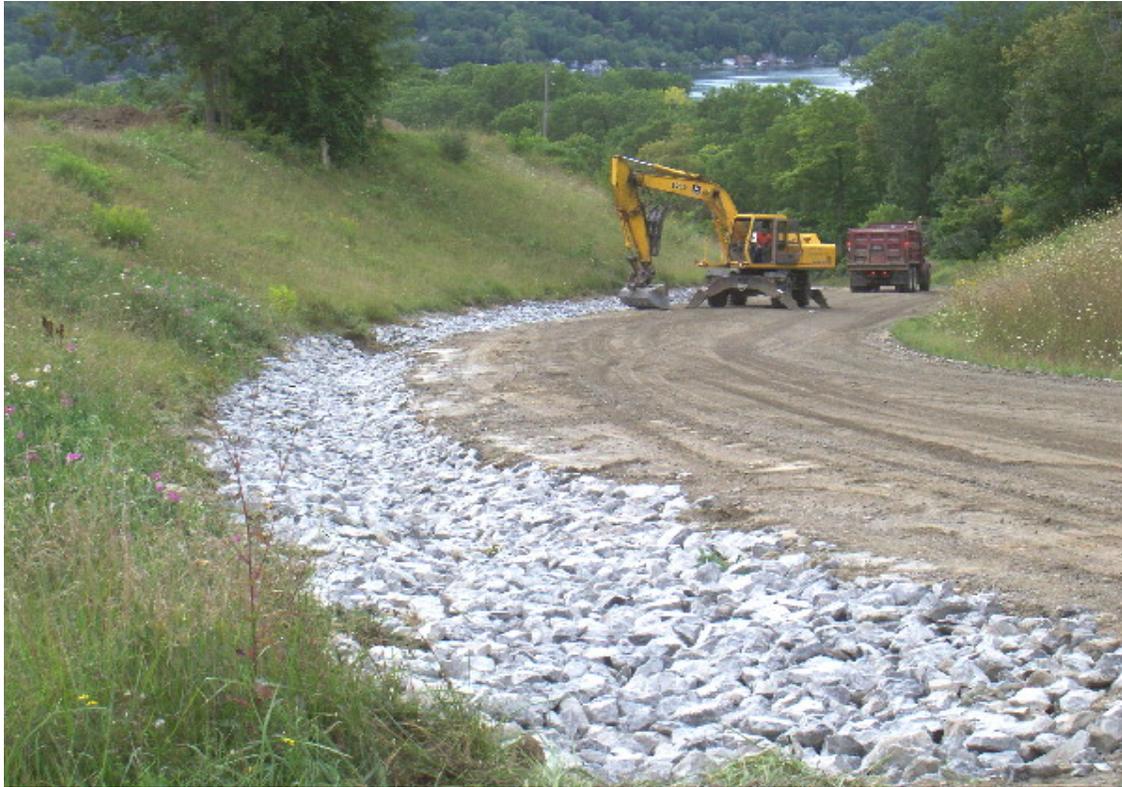
Although it appears that the new ditches are extremely shallow, the depth of the ditches includes over 3 feet of fill stone. Conesus Lake is visible in the distance.

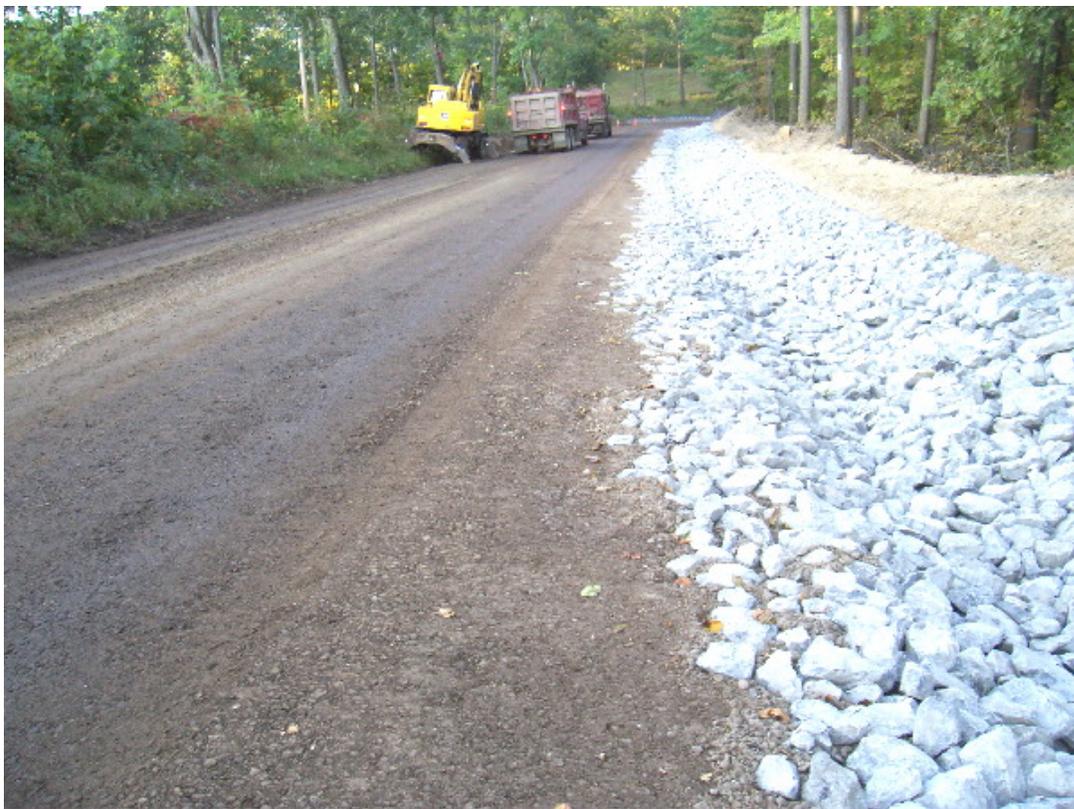
Nearing the top of the hill (looking west) in one of the steeper areas of the hill

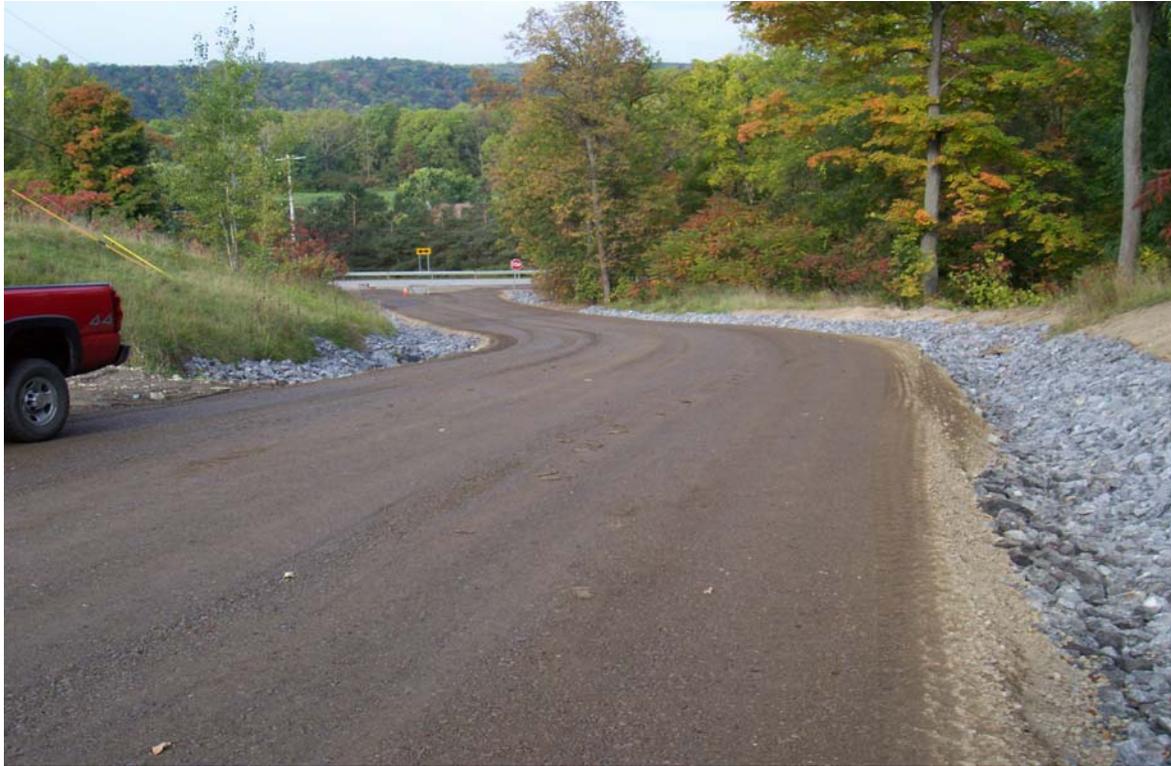
Taken September 2008, the roadbed finished and ready for oil and stone in 2009

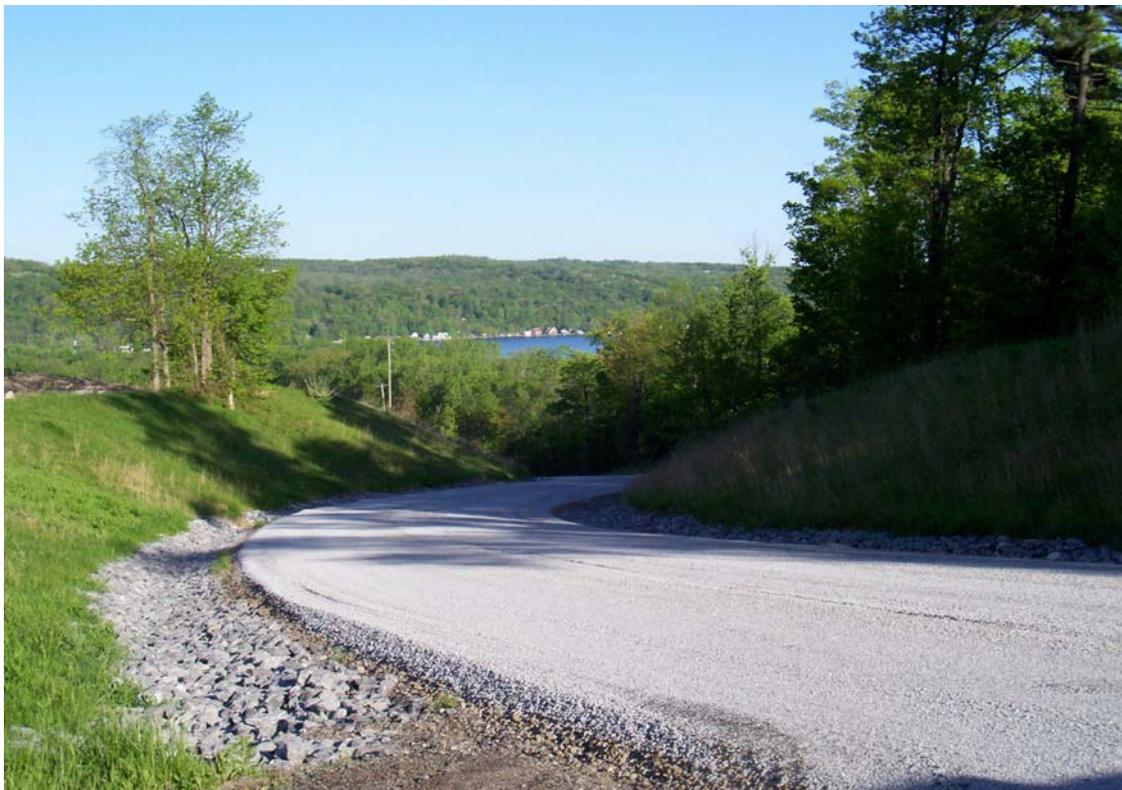
Taken after the road was oil and stoned on May 14, 2009. With the roadbed sealed the danger of road bed eroding is completely negated.
