During 2008 the Department was able to rebuild Henderson Hill Road with the assistance of a \$129,000 Department of Environmental Conservation erosion control grant.

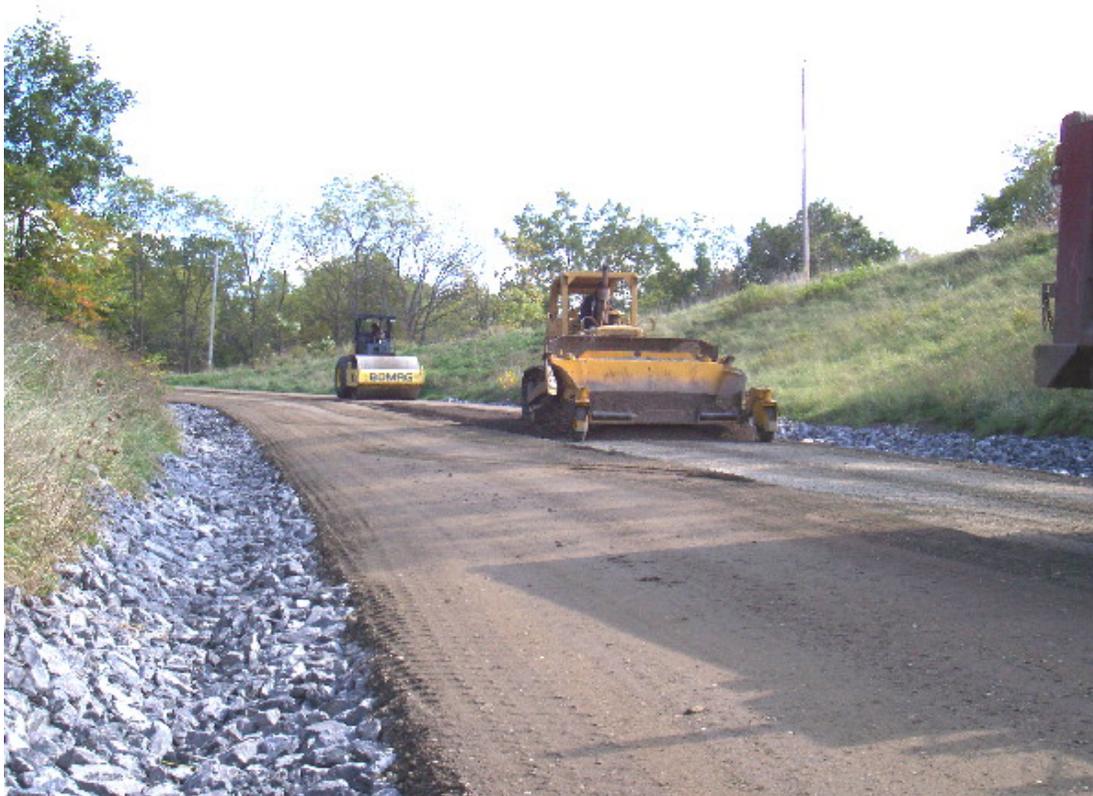
Finished with ditch construction and spreading new crushed gravel on the road using the "Jersey spreader". The spreader allows for a control width and depth of gravel. 12 inches of gravel was applied to the road which compacted to approximately 7 inches.
